Instrumentation and analysis of a railway embankment failure experiment

A general summary

Research reports of the Finnish Transport Agency
29/2011

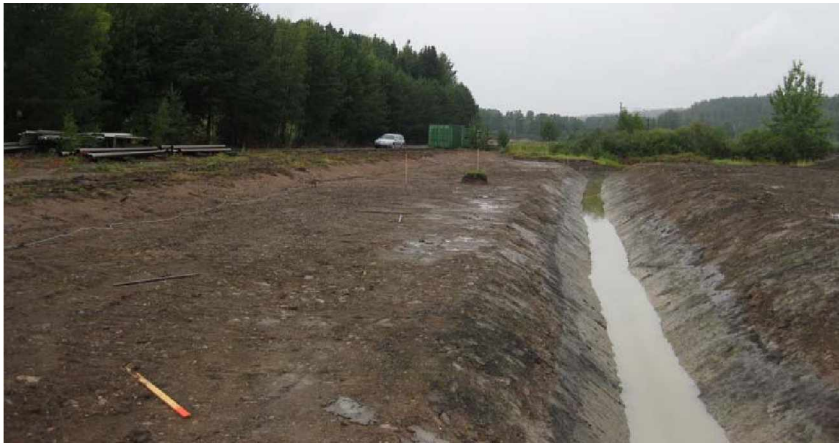
Figure 3 Site after geometry change. The embankment is yet to be constructed in the upper left corner of the picture.

To ensure a controlled failure, the inherent stability of the embankment was reduced by changing the cross-section geometry (Figure 3). A small embankment ($h = 0.6$ m, $L = 60$ m) was built in place of the old track, which was removed. A new track with concrete sleepers and K60 rails was built on the new embankment. To reduce stability and to control the slip surface location, a 2 m deep ditch was excavated (bottom at level +6 m, at a horizontal distance of 14.5 m from the embankment centreline). The ditch location was chosen based on initial calculations about the most likely slip surface, with the intention that the eventual slip surface would end at the bottom of the ditch. To further reduce stability, the ditch was kept dry during the actual experiment with a submerged pump. The top soil between the embankment and the ditch was removed to a depth of 0.3–0.6 m. The cut soil mass was placed as a small counter face behind the ditch to help contain the failure.

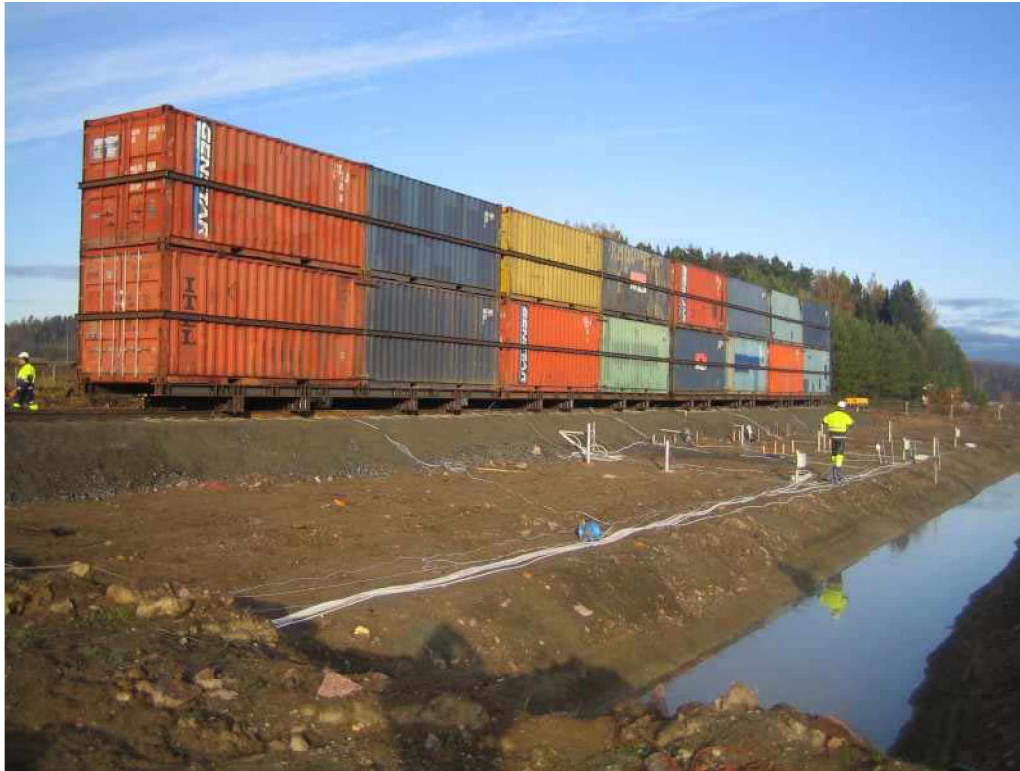
Figure 4 Site before loading. The ditch was drained of water prior to the start of loading. (Lehtonen 2010 p. 71)

A train (Figure 4) was simulated by four steel frameworks, each 12 m long. The frameworks consisted of transverse beams to simulate bogie carriages and longitudinal beams to support containers, which were gradually filled with sand. Each framework ('car') carried four modified sea containers in two tiers. The bottom containers had had their tops removed, while the top containers had had both their tops and bottoms removed. This way both container rows could be set in place before commencing the loading, which was done through the top containers. All containers were reinforced with horizontal steel bars running through them to brace against the earth pressure from the sand load.

The beams used in the frameworks were fairly large: an HE200B I-beam as the longitudinal ones and an HE300B as the transverse ones. The beams were also stiffened with extra steel plates in places where large shear stresses would occur.

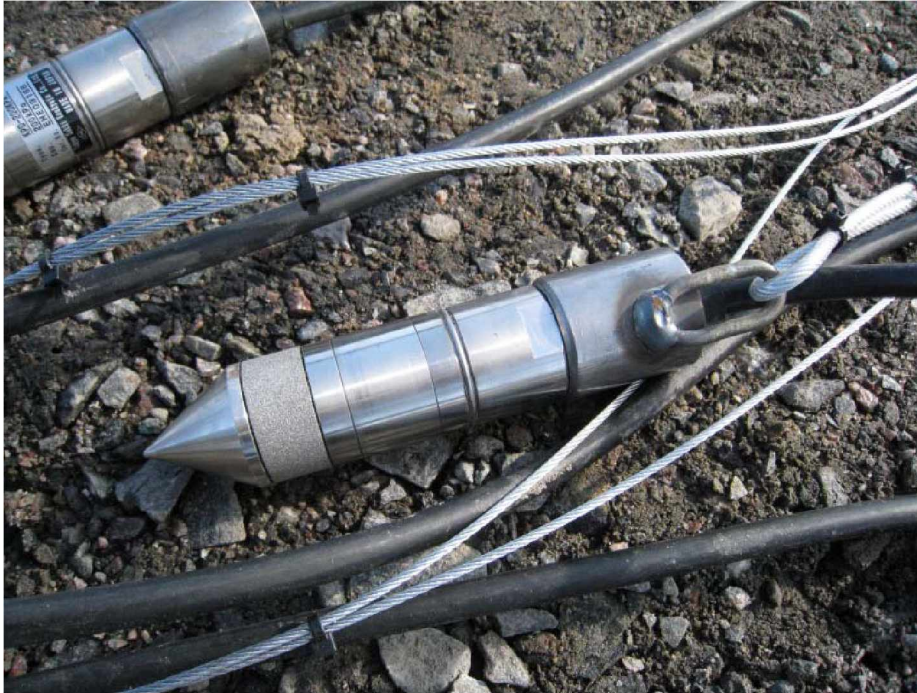
A total of 37 strain-type pore pressure transducers (Figure 7) were used in the experiment. They are off-the-shelf equipment intended specifically for measuring pore water pressure in soils. They have a conical tip for pushing them into the soil, and a porous stone in front of the membrane to isolate pore water pressure from earth pressure.

Figure 7 A pore pressure transducer. The end of the device has a thread-fastened bushing which fits a rod used to push the transducer into the soil. When the transducer is at a desired depth, the rod is pulled back up, leaving the transducer in place. The cable is used to recover the transducer after the experiment. (Lehtonen 2010 p. 41)

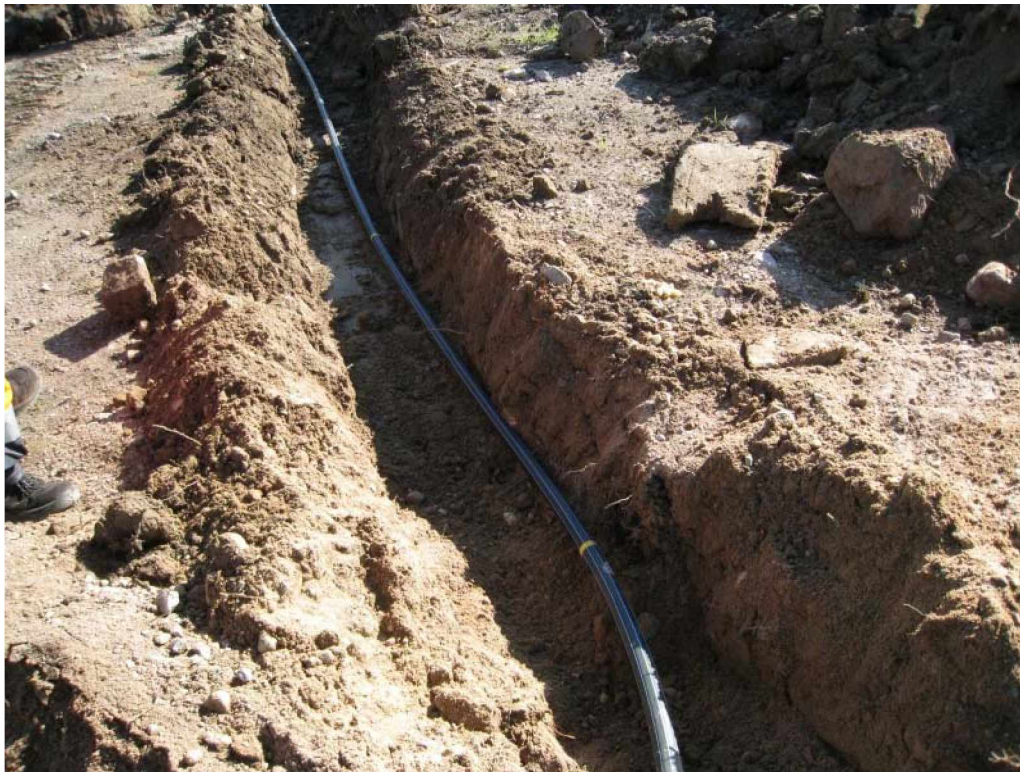
Figure 10 Settlement tube before covering. Transducer locations were marked with yellow tape and their co-ordinates were measured before covering the tube. Image by Kauko Sahi.

The transducers were assembled and installed in the tubes beforehand at the TUT workshop. On site the tubes had only to be laid down (Figure 10), filled with oil and the wiring connected to a computer before commencing measurements. The tubes were installed in 30–50 cm deep excavations in the sandy fill layer. The tubes must not be allowed to remain in direct contact with jagged particles (e.g. crushed rock aggregate), so as to prevent damage to them.

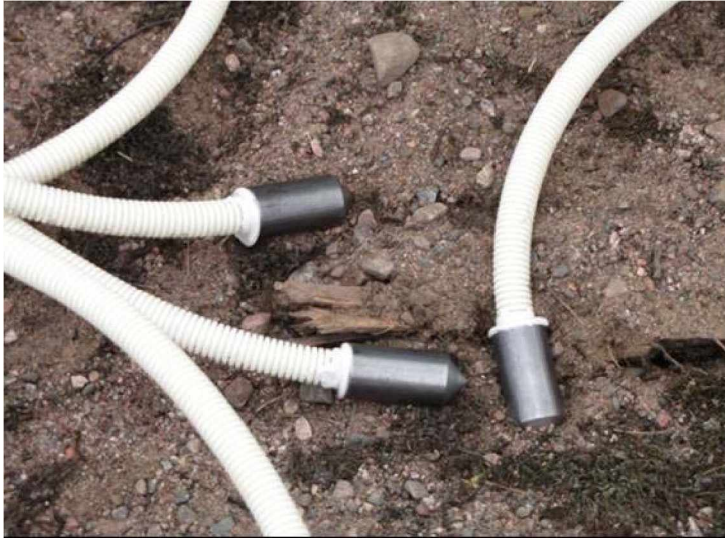
Figure 12 Slip surface measuring tubes (Lehtonen 2010 p. 52)

To estimate slip surface depth and the overall dimensions of the failure, flexible plastic tubing (used in electrical wiring applications, Figure 12) was installed vertically in the soil. The tubes were assumed to follow soil movements during failure and form a sharp bend at the slip surface. The depth of the bend can be measured from the surface after failure by using a wire with a rigid tip.

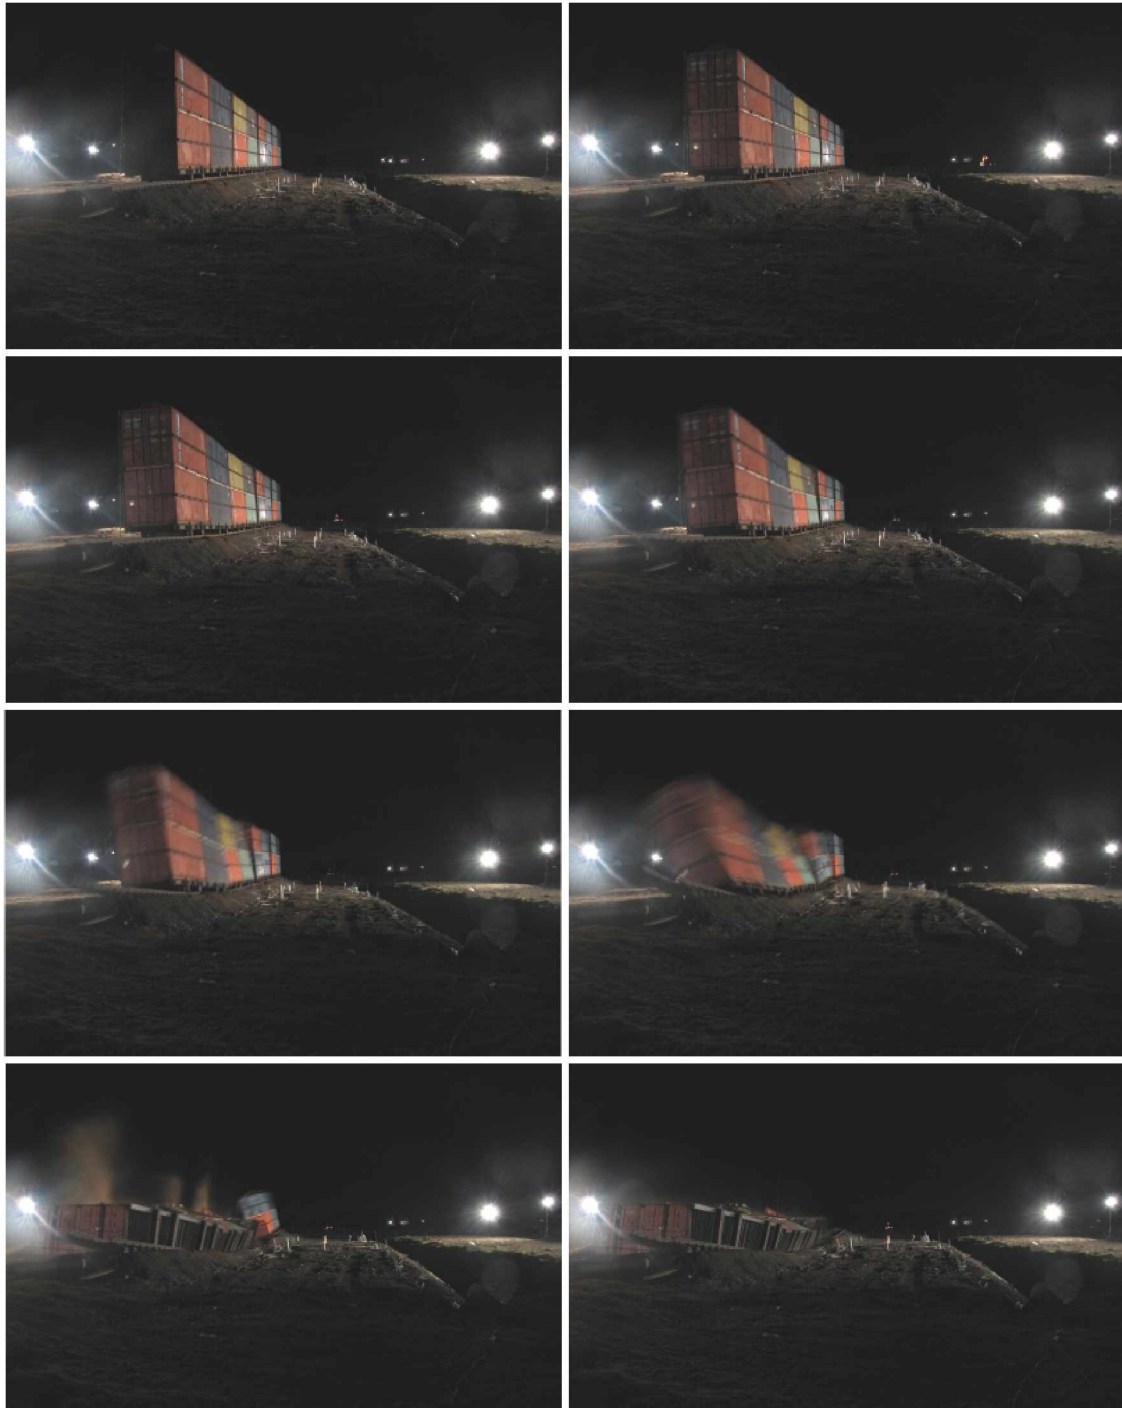
Figure 15 *The embankment failure. (Lehtonen 2010 p. 77)*

First visual signs of the failure were the tilting of cars 2 and 1 some minutes before failure. At failure (Figure 15), cars 1, 2 and 3 quickly sunk and fell on their side away from the embankment. Car 4 fell a few seconds later after fairly little settlement compared to the others. At failure, the embankment was displaced downwards (Figure

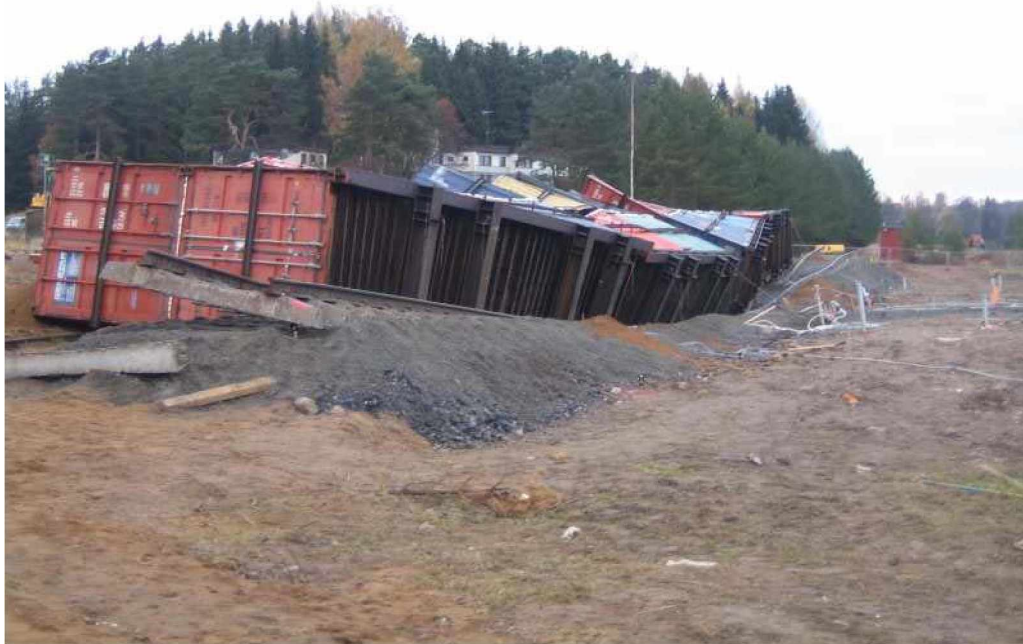
Figure 16 The embankment after failure. (Lehtonen 2010 p.78)

16), while soil between the embankment and the ditch moved upwards and towards the ditch.

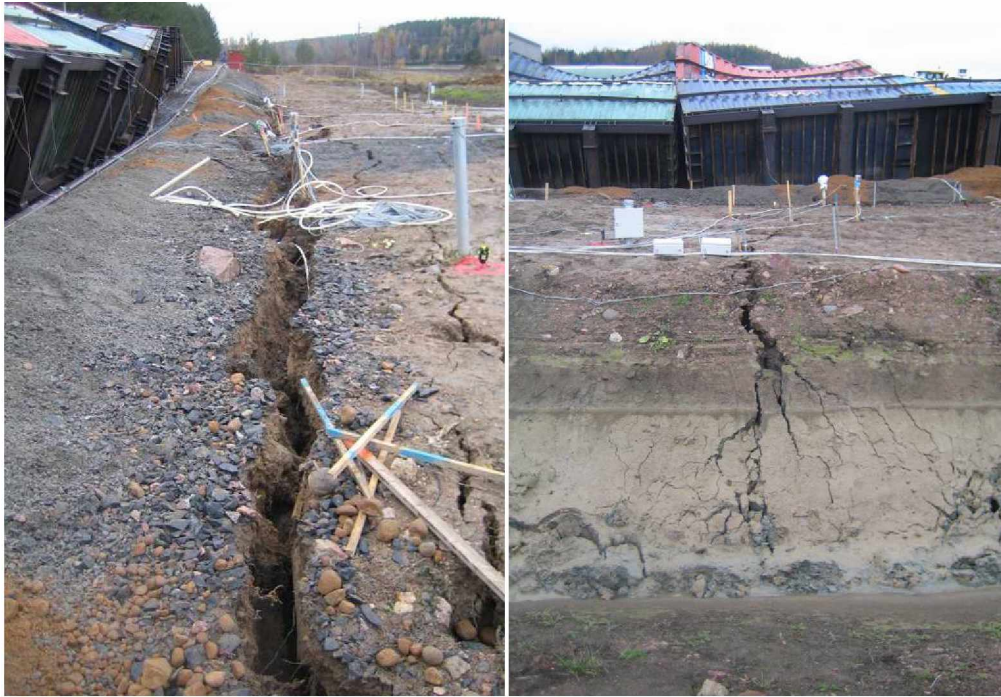
Figure 17 Left: Cracked soil at the embankment toe. Right: Crack by the ditch in the center part of the area (spot of largest ground rise) (Lehtonen 2010 p.79)

The general shape of the failure was evident from visual observations. The slip surface began behind the sleepers and ended on the bottom of the ditch. The longitudinal extents of the slip surface could be approximated from diagonal cracks on the surface. The failure mechanism consisted of two different parts: the embankment had moved down while other parts had moved up and to the side. The soil had cracked at the embankment toe, where the two soil masses had most likely moved in opposite directions vertically. Largest displacements were observed in the middle of the area. (Figures 17 and 18)
